**FRETTING FATIGUE BEHAVIOR OF SHOT-PEENED TITANIUM ALLOY
TI-6AL-4V UNDER SEAWATER CONDITIONS**

THESIS

AFIT/GAE/ENY/04-J01

**DEPARTMENT OF THE AIR FORCE
AIR UNIVERSITY**

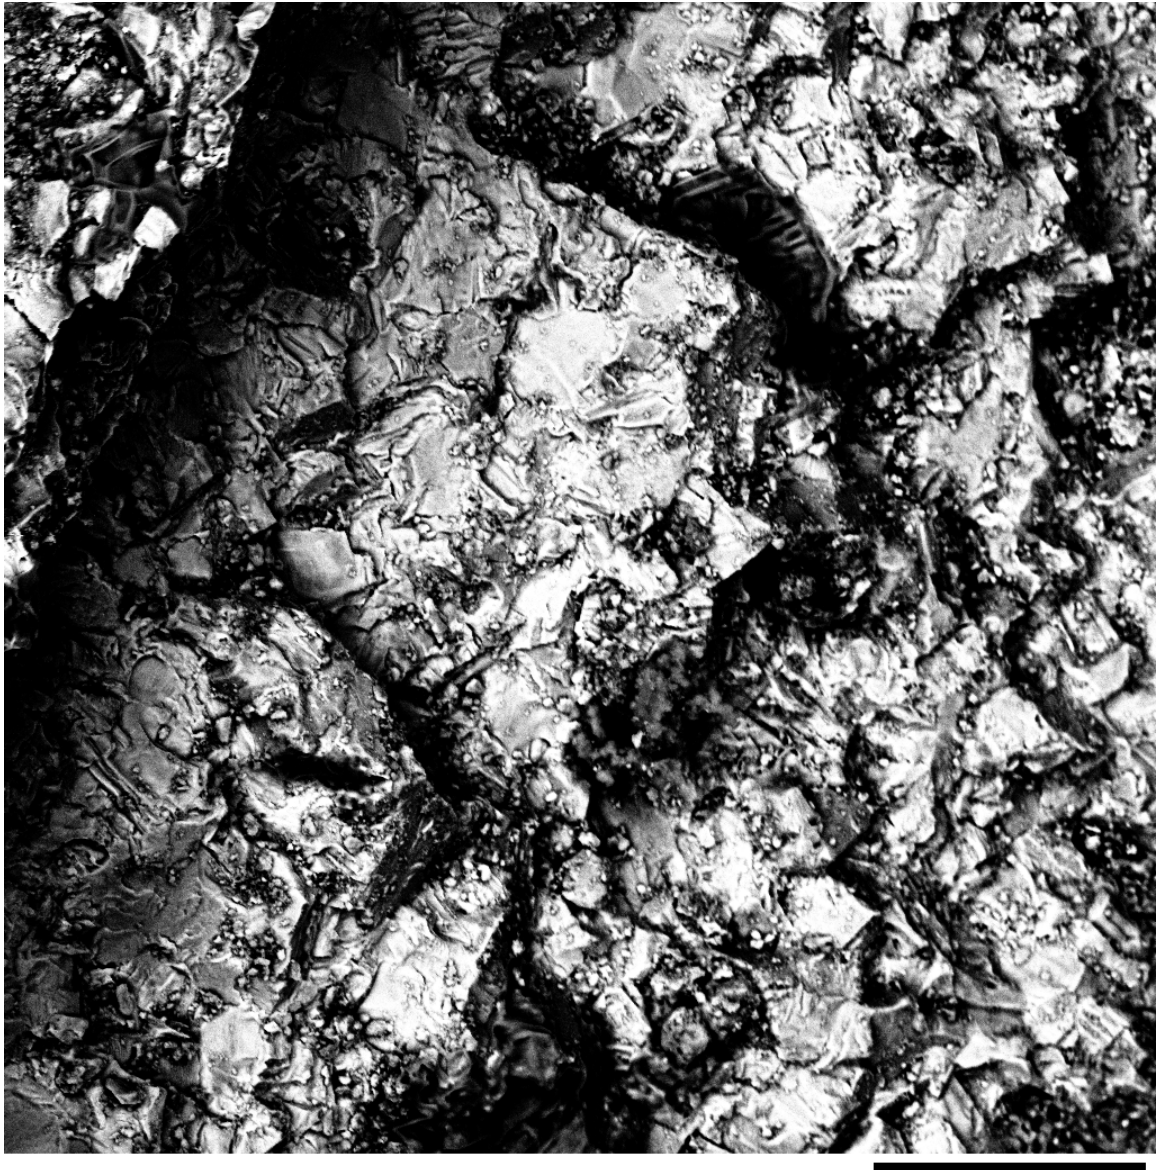
C.2. BSE SEM of fracture surface exposed to seawater conditions at $\sigma_{\text{eff}} = 544$ MPa under high magnification.
